FORT BEND COUNTY LEVEE IMPROVEMENT DISTRICT NO. 19

AFTER ACTION REPORT

BY COSTELLO, INC.

HURRICANE HARVEY – 2017

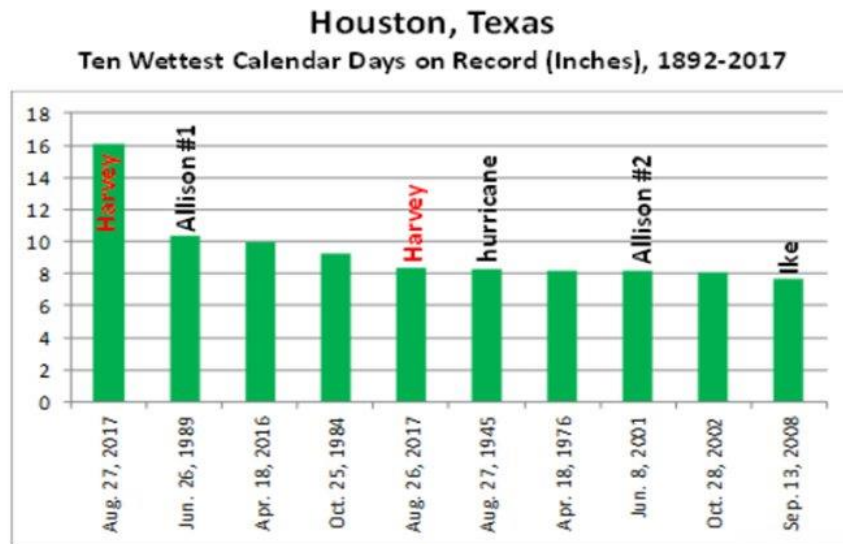
Houston's Ten Wettest Days on Record

Two of the 5 wettest days on record in Houston occurred with Harvey (16.07" and 8.37").

Image courtesy of
NWS Southern Region
